# INDOOR AIR QUALITY ASSESSMENT

**Lowell High School  
“1980 Building”  
50 Father Morissette Blvd  
Lowell, MA**

Prepared by:  
Massachusetts Department of Public Health  
Bureau of Environmental Health  
Indoor Air Quality Program  
August 2017

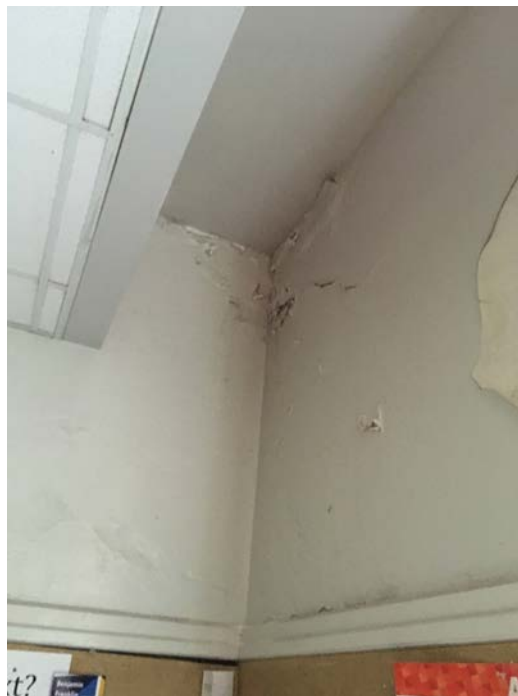
**Picture 8**

Water-damaged ceiling tiles and plaster walls were observed in many classrooms, offices, and hallways (Pictures 6 through 8; Table 1), indicating leaks from the building envelope or plumbing system. Ceiling tiles should be replaced after the leak is found and repaired. In general, ceiling tiles have an open space above them (the ceiling plenum) and tend to dry out quickly, reducing the chance for mold colonization. Ceiling plaster does not contain organic material; therefore, it will not support microbial growth even when frequently moistened. In some cases, dust or paint on the surface of plaster can become mold colonized. If this occurs, plaster can often be cleaned to remove the mold.

**Water-damaged ceiling plaster**

1. Replace any water-damaged or mold-colonized porous building materials (e.g., ceiling tiles, gypsum wallboard, carpeting) in classrooms, hallways, and stairwell areas. Ensure water-damaged materials are cleaned, replaced, and/or repaired in a manner consistent with the U.S. Environmental Protection Agency’s guidelines (US EPA, 2008).

2. Consult with a roofing contractor to assess the roofing system. Repairs should be made to stop leaks and chronic water damage to building materials. The roofing system should then be monitored regularly for water pooling, leaks, and other deteriorating conditions.
